THE 2020 PV MODULE RELIABILITY SCORECARD

PV Evolution Labs (PVEL)

May 28, 2020

Analysis of Historical PQP Module Test Data & Extending Useful Life

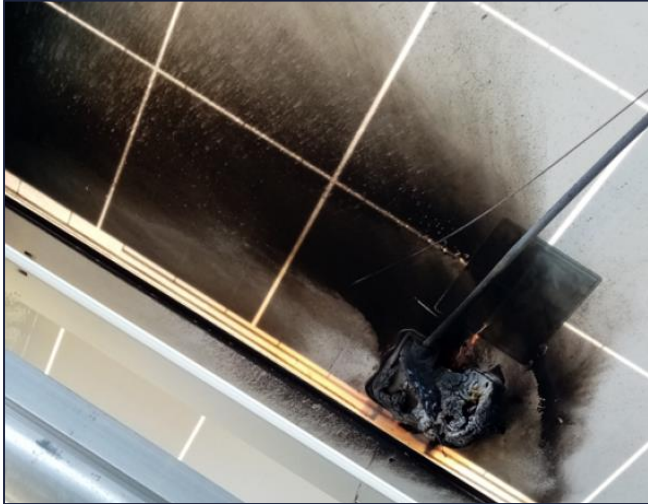
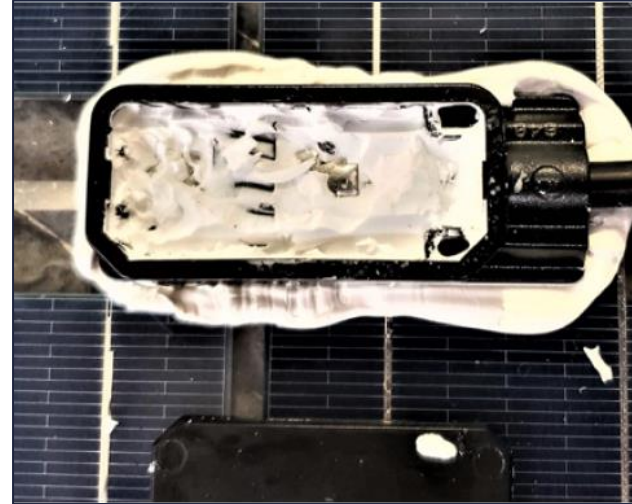
2020 Scorecard: Failures

- › **20% of eligible BOMs had at least one failure.**
- › The highest amount of failures were safety-related from wet leakage testing.
- › One in five manufacturers tested for the 2020 Scorecard period experienced at least one junction box-related failure.

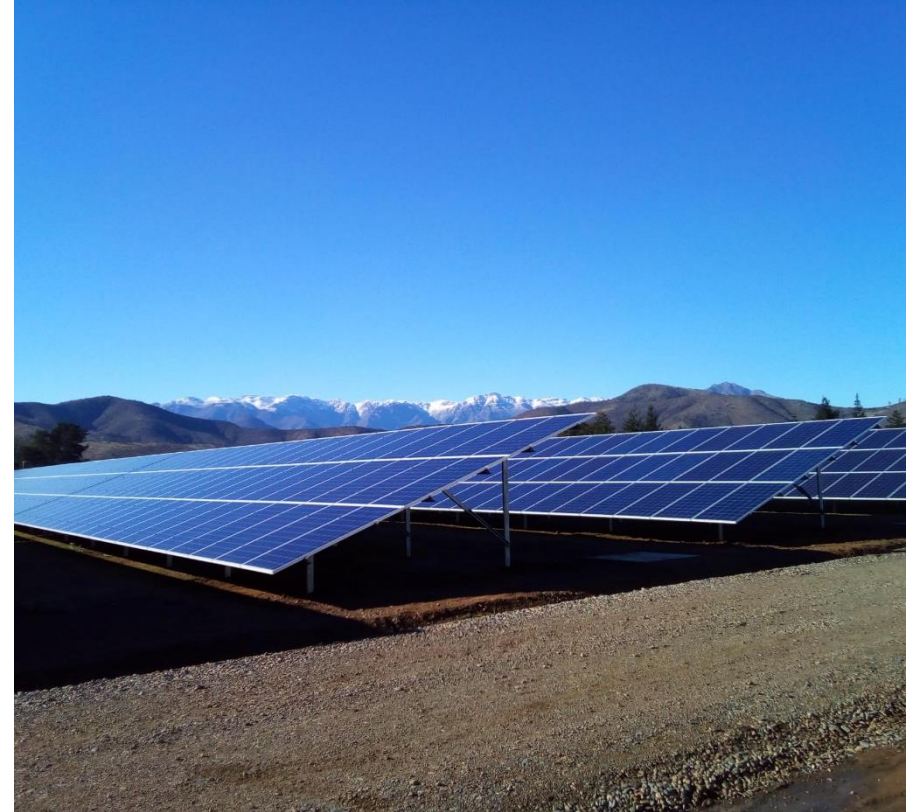
Trends in PQP Tests 2014-2019 Results

- DNV GL analyzed PVEL PQP test results from 2014 to present
- While the PQP has evolved over time, TC600 and DH2000 have remained common tests with statistically significant trends
 - Statistically significant trends demonstrate a $p < 0.05$
- All data analysis by:
 - Henry Hieslmair, Ph.D.
 - Principle Engineer, Solar Technology, DNV GL

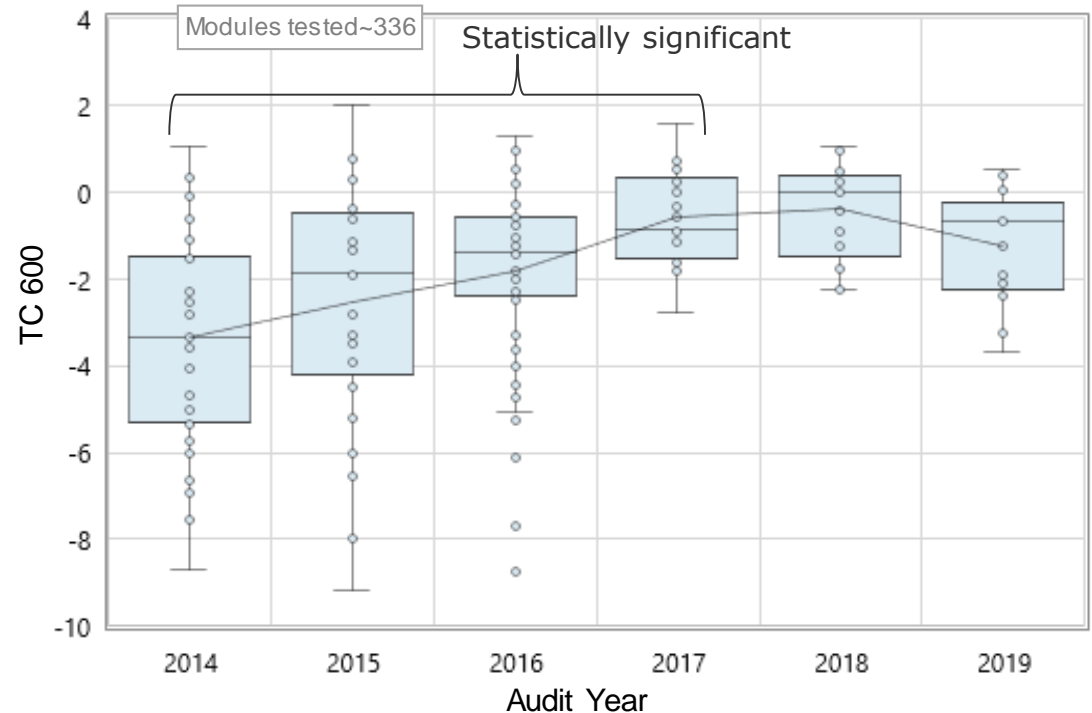
Trends in Thermal Cycling – TC600

- TC600 results improved 2014 to 2017
- Plateau with little degradation after 2017
- This improvement may be explained by:
 - Transition to monocrystalline cells
 - Increased number of busbars
 - Thicker encapsulants

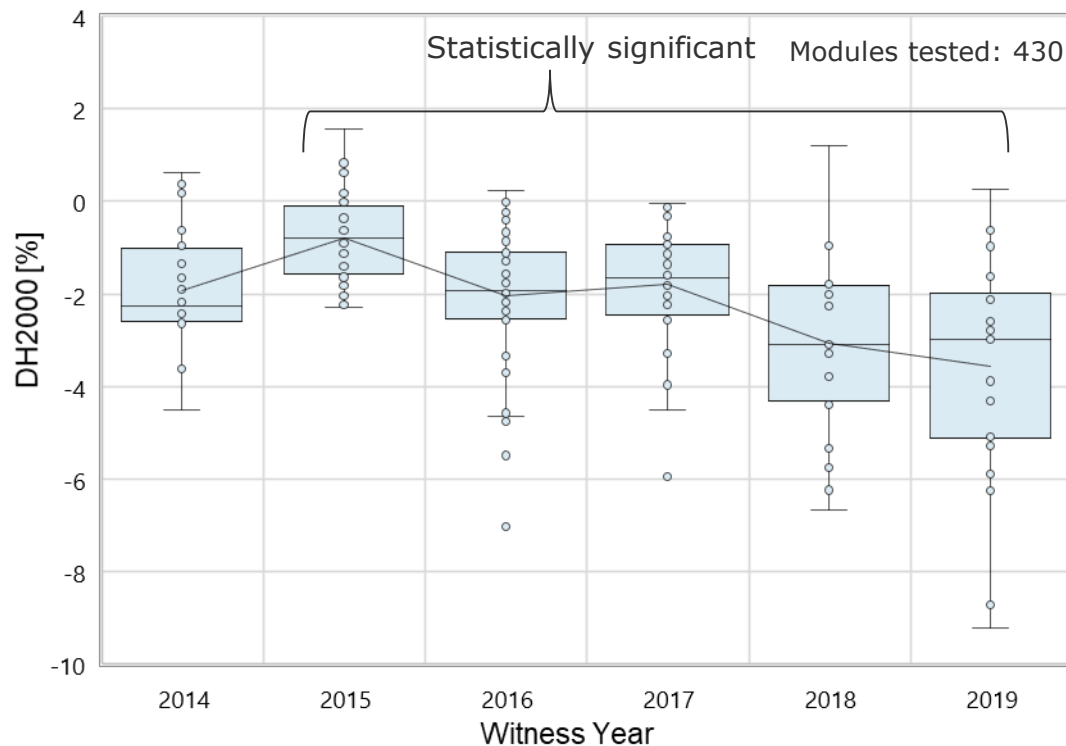
Trends in Damp Heat – DH2000

- Damp heat 2000 results indicate a deteriorating trend since 2015
- This may be due to the adoption of PERC cells which may require the additional boron-oxygen LID stabilization step following DH2000
 - As highlighted in the 2020 Scorecard
- Alternatively, may reflect utilization of non-fluoropolymer backsheets or thinner screen-printed fingers, which may be more sensitive to corrosion via moisture ingress.

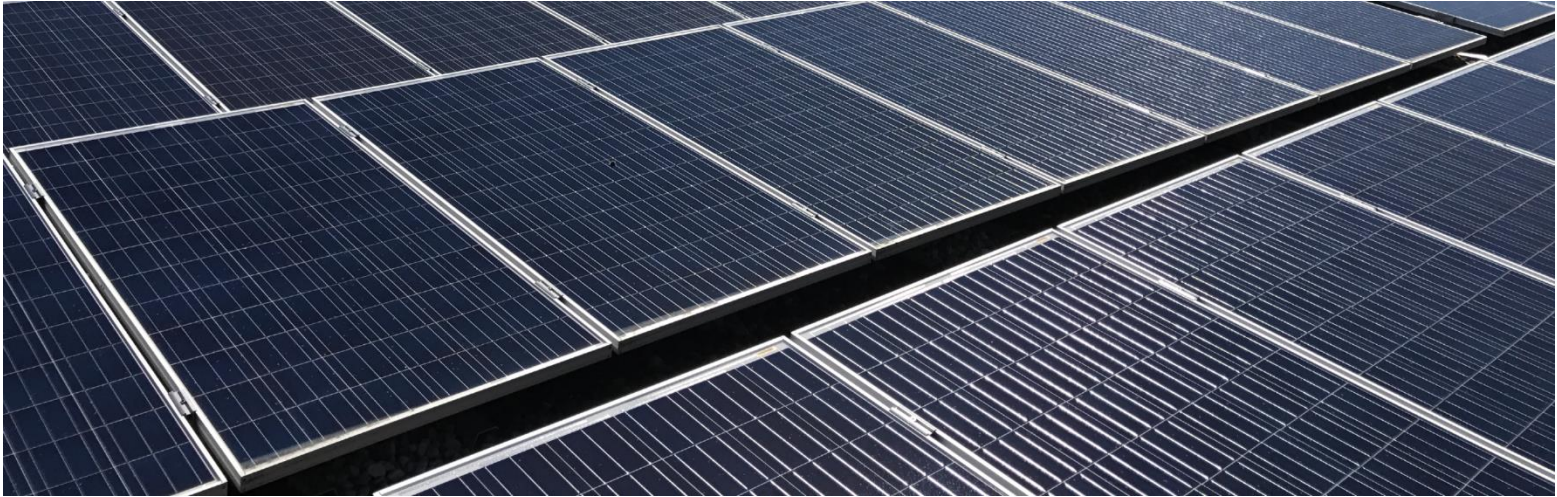
Ideal Test Duration

- Ideal test durations are often debated. The tests are meant to simulate stresses and degradation mechanisms that occur in the field.
- If the test duration is too short, degradation may not be detected. If the duration is too long, then new, non-representative failure mechanisms could be introduced.

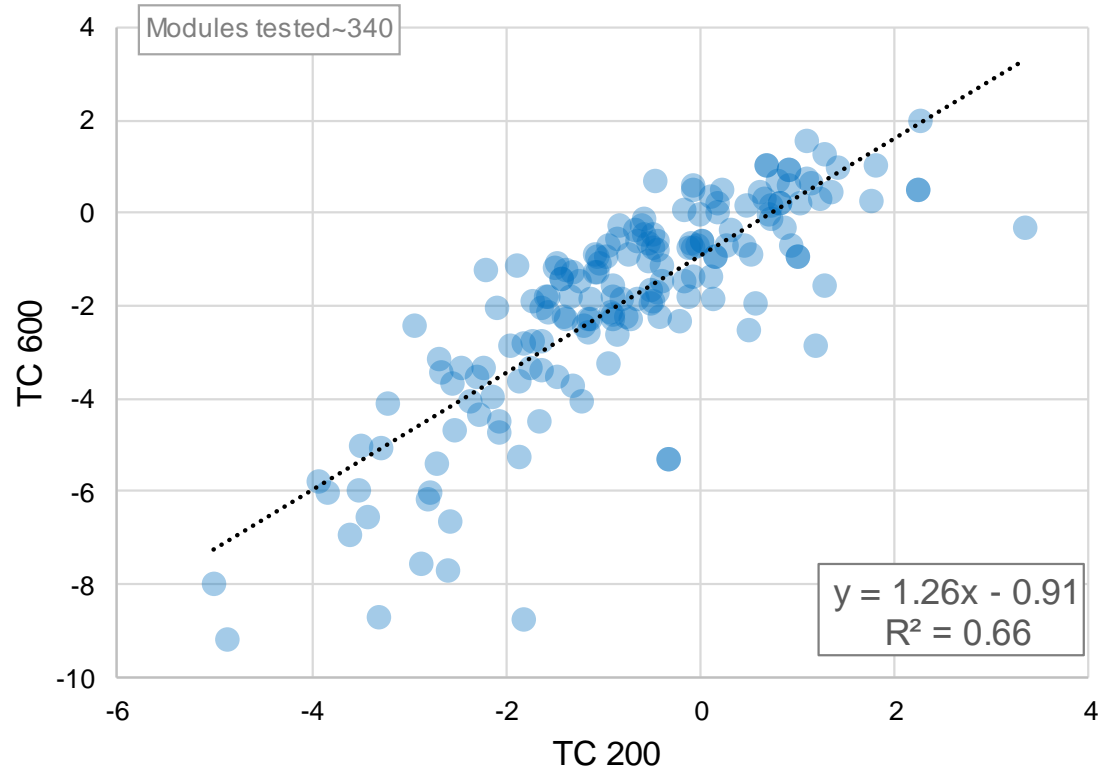
Ideal Test Duration – TC 600 vs. TC 200

- Thermal cycling test
- Correlation between 200 cycles and 600 cycles indicates no new mechanisms introduced by the 600 cycle test
 - Data show stopping at 200 cycles might be premature
- Reviewing the historical 600 cycle and 800 cycle
 - Correlation indicates that TC600 is a sufficient test duration with very good agreement

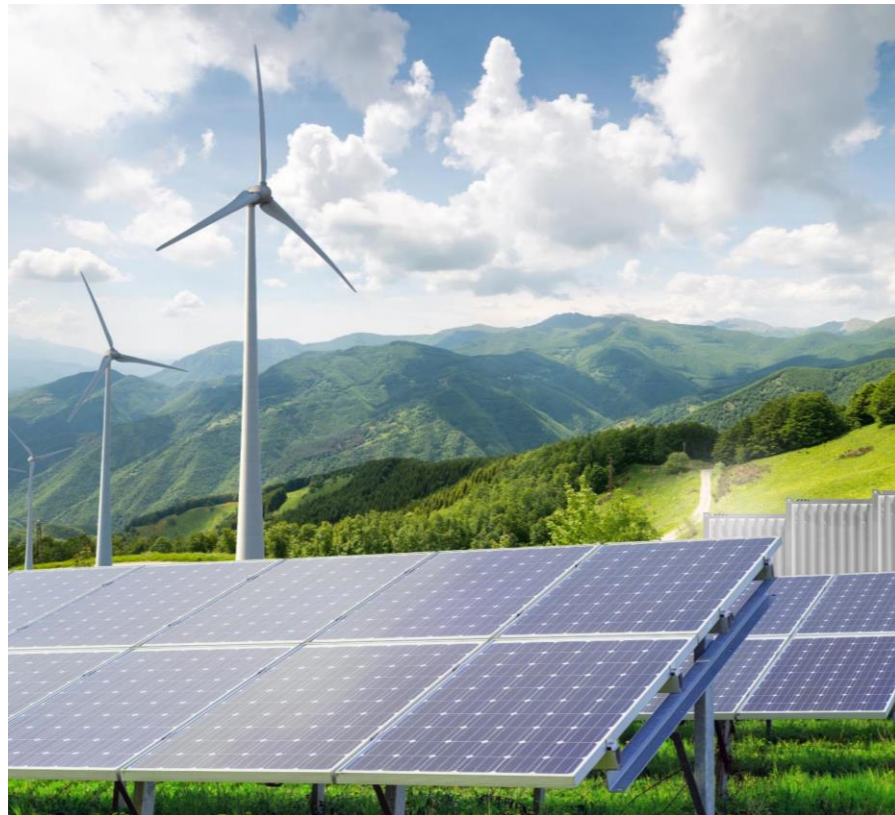
Using PVEL's data in DNV GL's useful life assessments

- Extending system life beyond 25 years
- DNV GL determines the module useful life by considering the failure rate of the module
 - Where failure is defined as a significant drop in module power in a short period of time
 - Causes could include PID, corrosion, failed backsheets, etc.

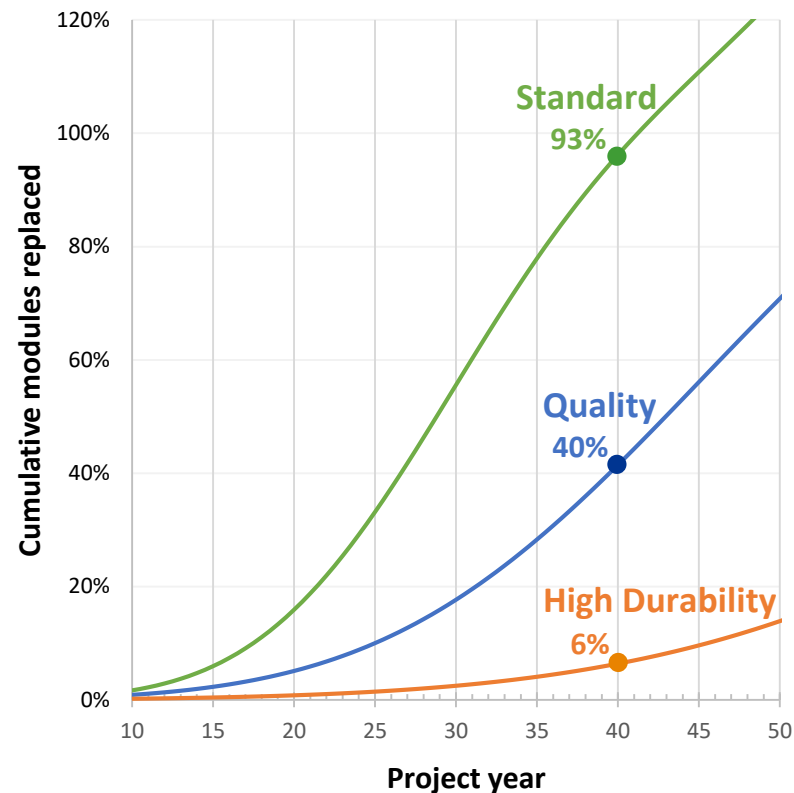
Module Classification and Impact on Useful Life

- DNV GL has developed a three-tier module classification:
 - Standard, Quality, and High Durability
 - With associated failure rates and replacement schedules
- PVEL's PQP enables module classifications through an extensive suite of accelerated stress tests
- Additional classifications considerations include:
 - Factory audit reports
 - Detailed BOM review
 - Historical field data
- Targeting a system life of 40 years would entail almost all of the Standard modules to be replaced
- Only 40% and 6% of the Quality and High Durability modules would be replaced, respectively.
